**PRELIMINARY ENGINEERING OPINION**

# **POTENTIAL INDUCED CHANNEL BANK EROSION WITHIN SANDALWOOD CANAL/HOGPEN CREEK**

Devo's Project No: 14-889.01

Potential Induced Channel Bank Erosion within Sandalwood Canal/Hogpen Creek adjacent to Residential Property @ 2194 San Pablo Road South, Jacksonville, FL 32224

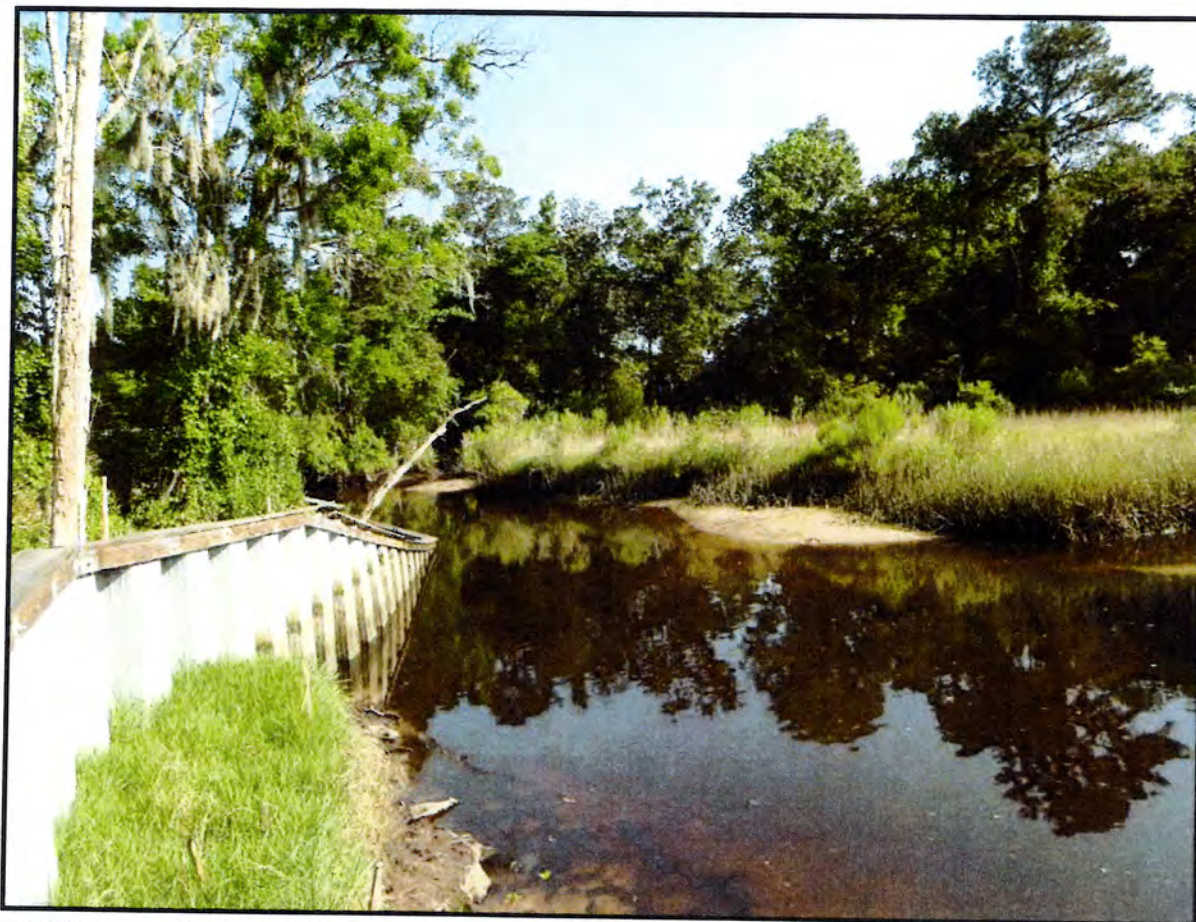
- ① erosion, undermining and collapse of a segment of the sheetpile retaining wall on your property (see Exhibit 8, next page), and
- ② erosion and loss of significant portions of the stream bank adjacent to the upland portion of your property and also to the shoreline of the island within the channel (within the property limits).

Exhibit 8. Collapsed Sheetpile Retaining Wall (4/27/2014)

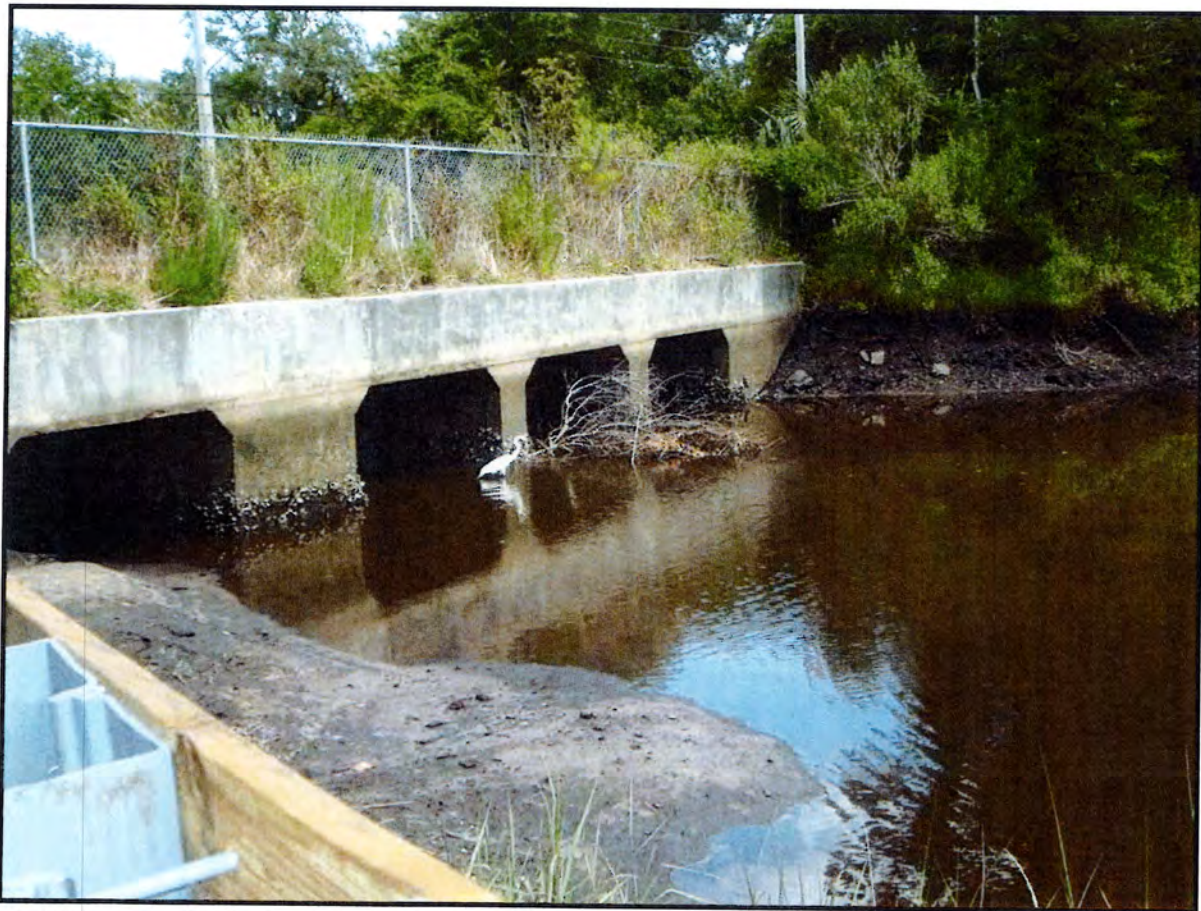
Note that Hogpen Creek is tidally influenced, and experiences daily fluctuations in water level. Exhibit 1 below shows a photograph of the box culvert beneath San Pablo Road. Based on the apparent stain lines, and elevations estimated from the construction plans, the water level in the creek appears to frequently reach an elevation of about +2.5 ft or greater, i.e., 6± inches below the top of the culvert opening, and also appears to exceed the top of the box culvert elevation somewhat frequently (roughly, elevation +3.5 ft).

Exhibit 1. Box Culvert Under San Pablo Road (1/18/2008)

In 1996-1997, the City made changes to the Hogpen Creek box culvert under San Pablo Road to increase its capacity and added a sediment sump downstream; the upstream invert was also lowered. These improvements are shown in the City of Jacksonville construction plans dated November 7, 1995, with a detail of the box culvert excerpted and included in Attachment 1. From these plans, note the following:

- The crest of roadway is at elevation +8.6 ft
- The top of the headwall is at an approximate elevation of +5.5 ft
- The top of the culvert opening is at an approximate elevation of +3 ft

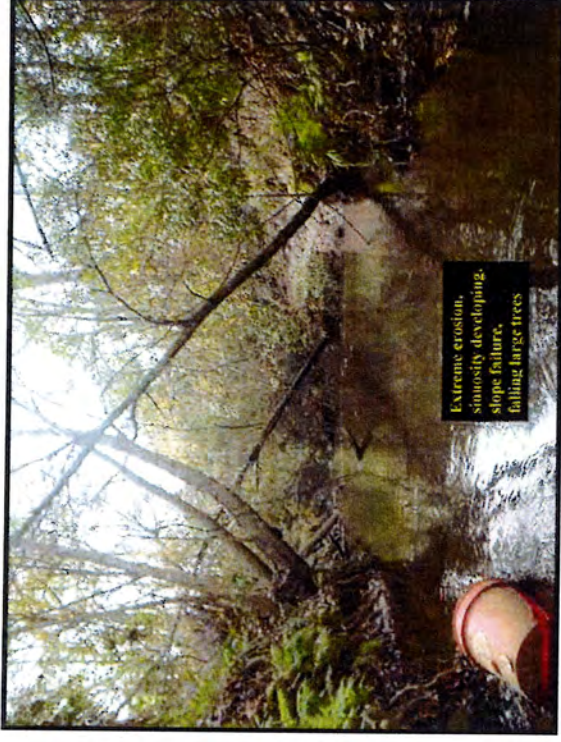
Exhibit 3. Predevelopment Conditions in Sandalwood Canal Section

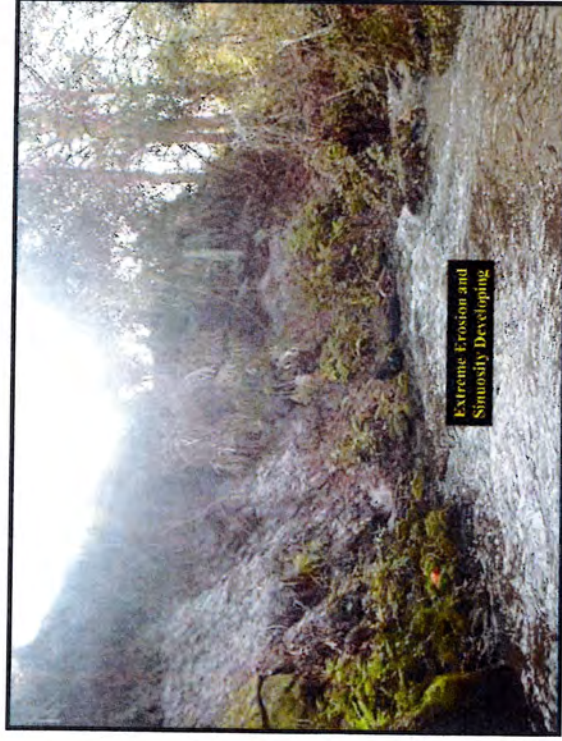
Exhibit 4. Predevelopment Conditions In Sandalwood Canal Section

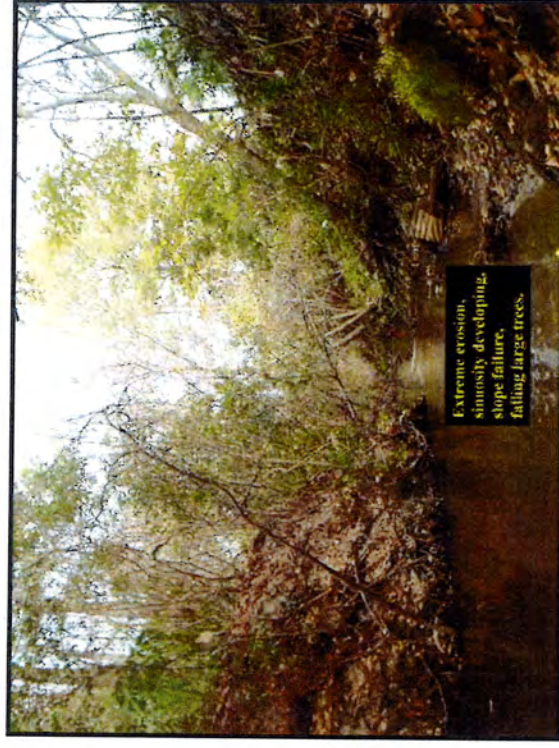
Exhibit 5. Predevelopment Conditions In Sandalwood Canal Section

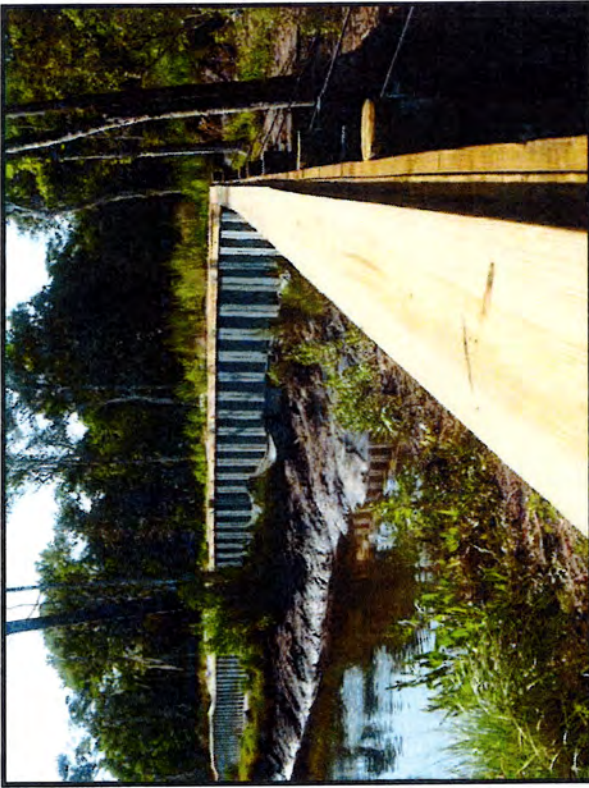
Following the roadway and canal improvements in 2007-2008, Mr. Ellis (the owner of the property at 2194 San Pablo Road South, Jacksonville, FL 32224) has experienced excessive stream bank erosion which has culminated in the undermining and collapse of a segment of his retaining wall. The photographs in Exhibits 8 through 11 were all taken after the roadway and canal improvements. Exhibits 8 and 9 predate the collapse of the sheetpile retaining wall, while Exhibits 10 and 11 are post-collapse.

Exhibit 8. Stream Bank Erosion (5/20/2011)

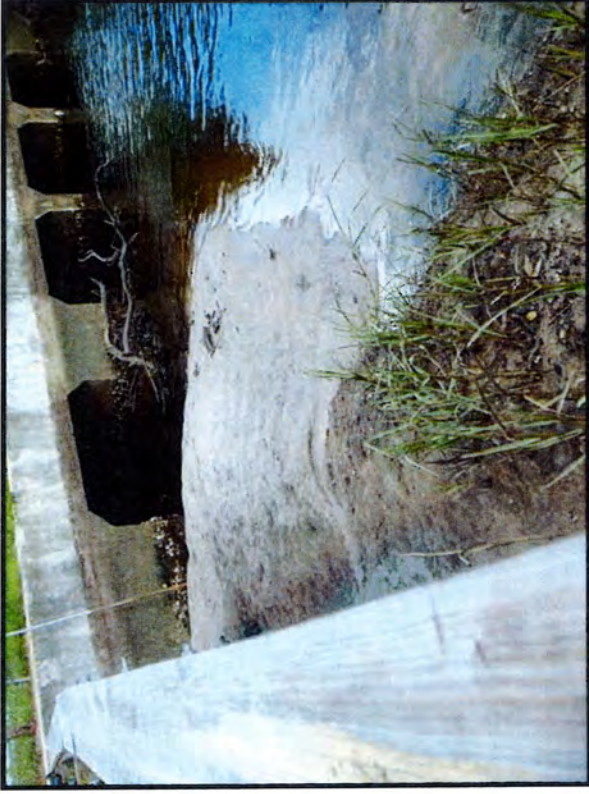
Exhibit 9. Deposition Of Eroded Sediments (6/20/2012)

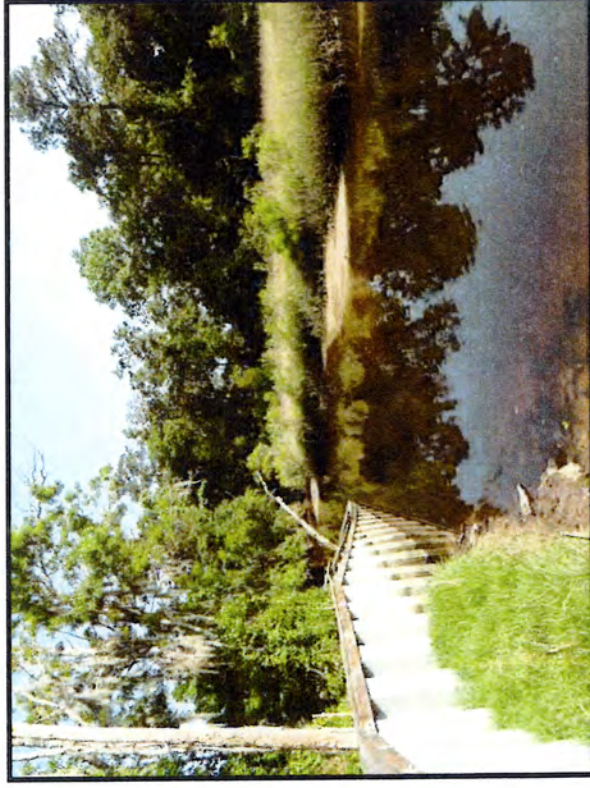
Exhibit 10. Collapsed Sheetpile Wall (4/27/2014)

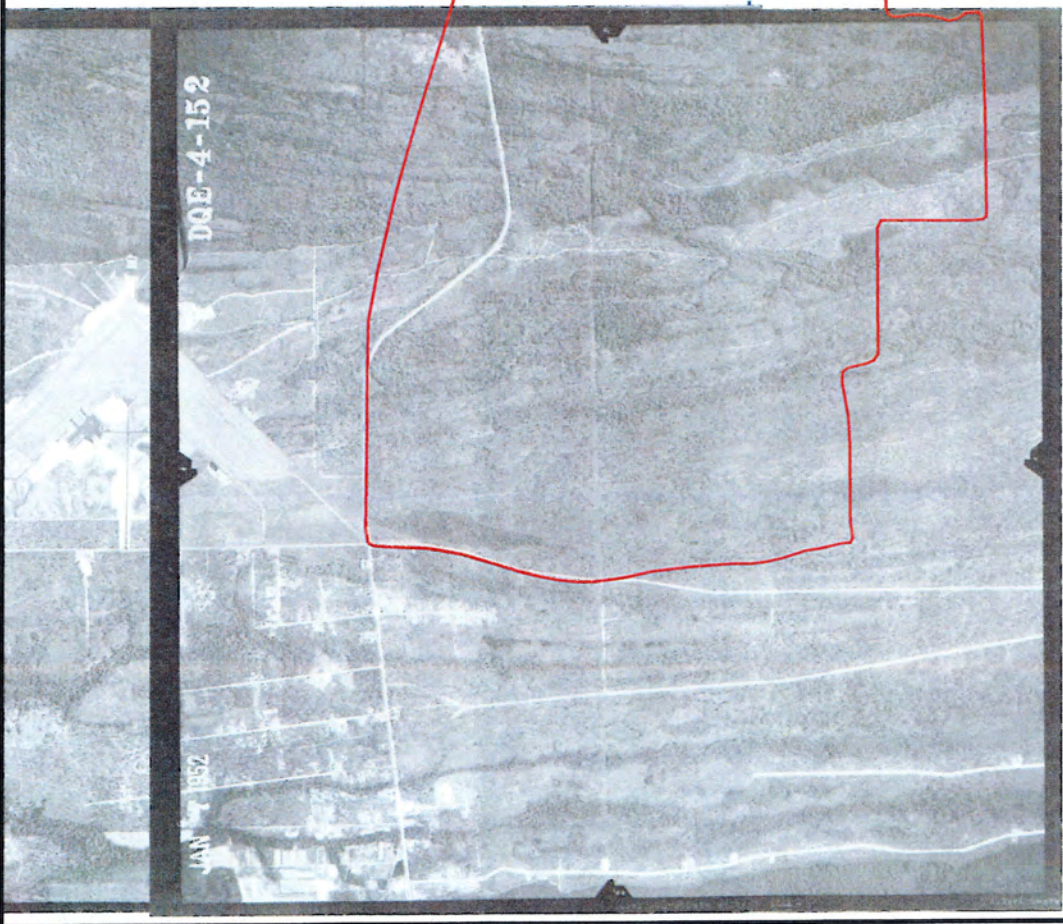
Figure 2.2

Sandalwood Canal is a man-made ditch that was constructed sometime in the 1950's to provide drainage for upstream development. The canal does not appear in the historic aerial from 1952 (Figure 2.2), but it is clearly visible in the historic aerial from 1960 (Figure 2.3). The canal is approximately 4.3± miles long, oriented east-west, and drains a basin area of approximately 4,300 acres (6.7 square miles). The watershed limits for Sandalwood Canal are shown on Figure 3.1. The basin is now predominantly comprised of medium-density residential development (overall Directly Connected Impervious Area of 13% per CDM). It is characterized by a flat land surface topography and poorly drained soils. As development has progressed within this basin, adding impervious area, the flow rates and flow velocities in the canal have increased causing erosion and silt buildup downstream.

**1952**  
**Historical Aerial Image**

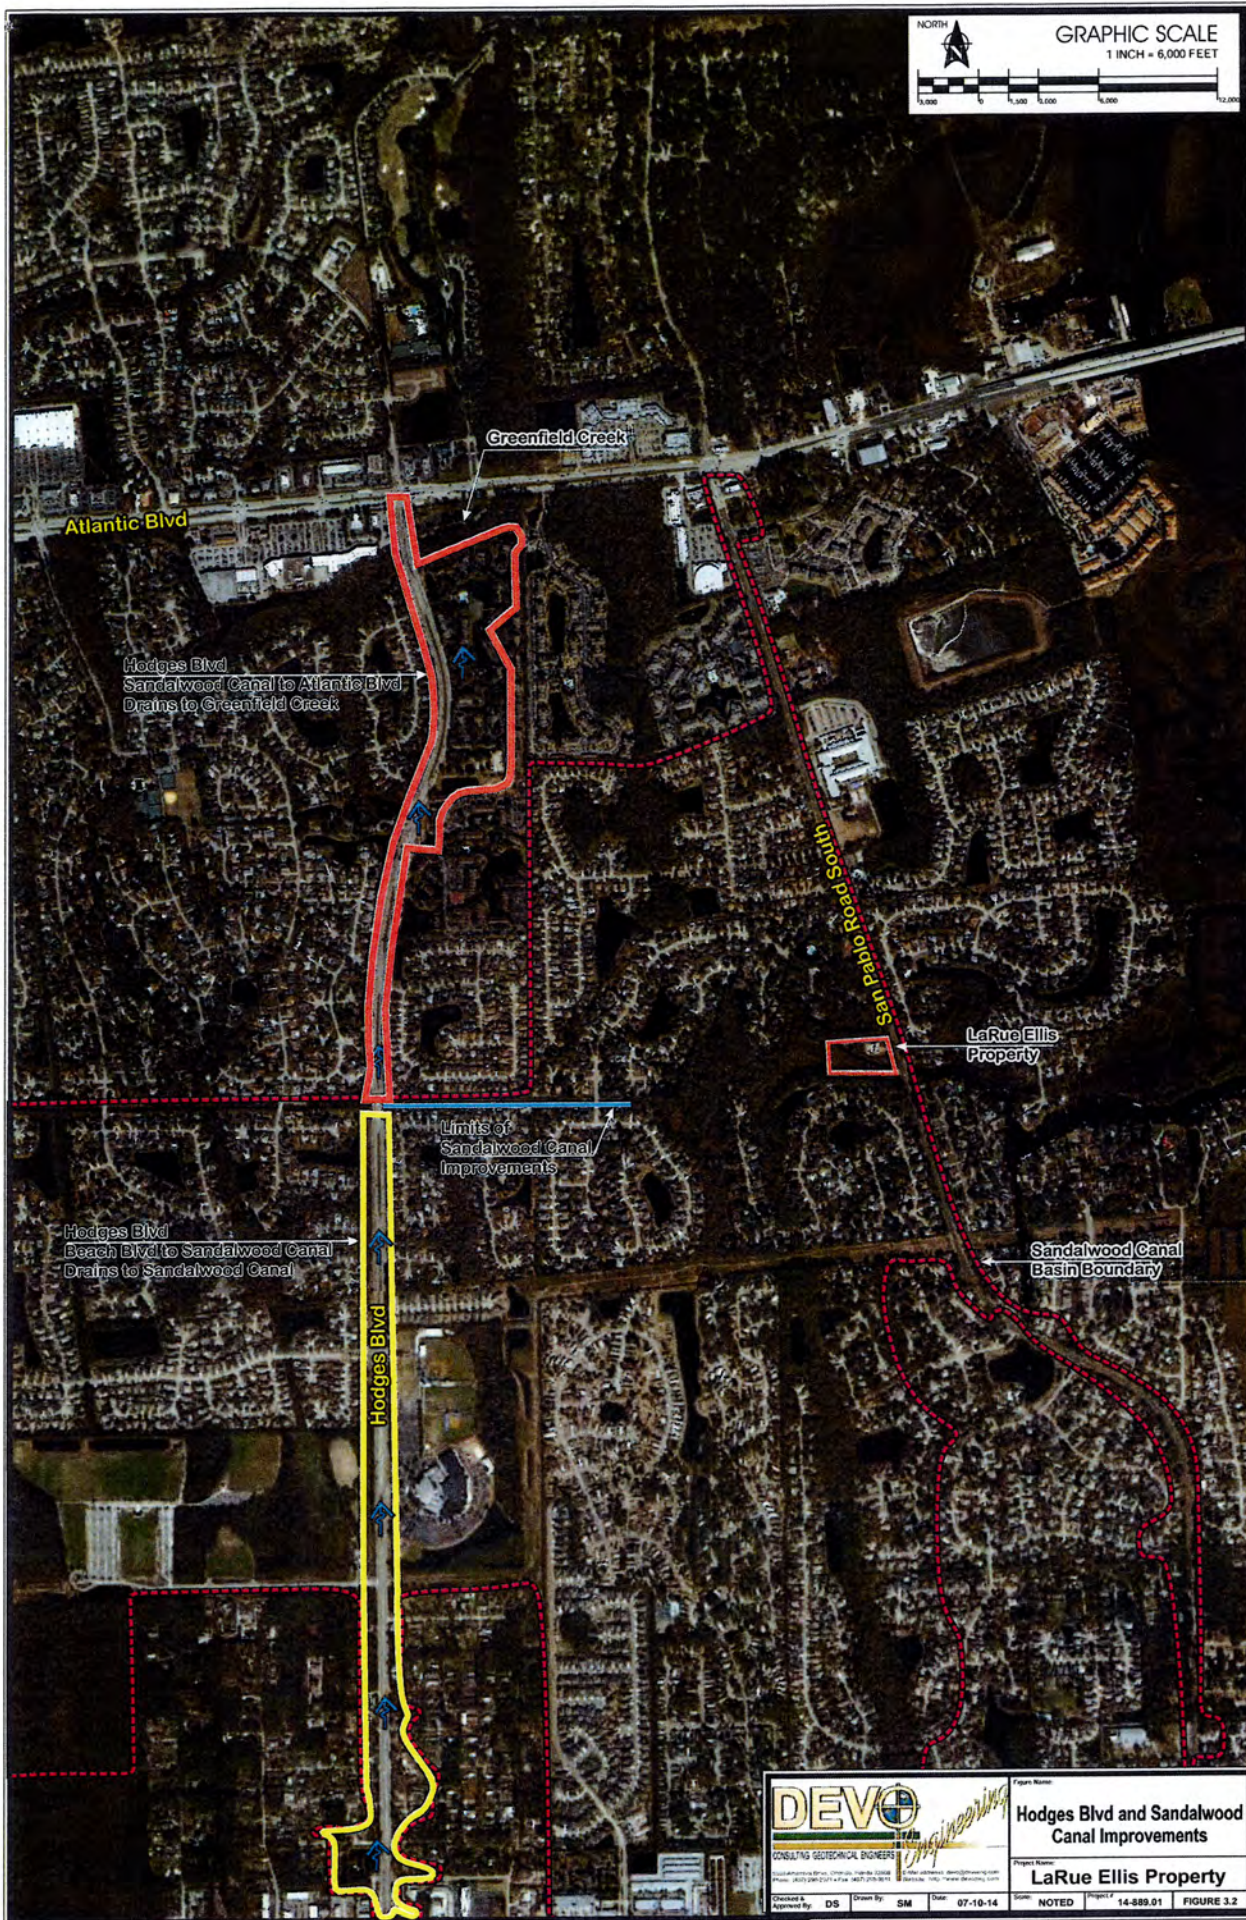
Checked & Approved By: **DS** Drawn By: **SM** Date: **07-10-14** Scale: **NOTED** Project # **14-089.01** FIGURE 3.2

In 2007-2008, the City of Jacksonville undertook improvements to a 2,100± lineal ft section of the Sandalwood Canal, from Hodges Blvd eastward to a point of discharge just upstream from the Hogpen Creek marshes. The location of the affected canal section is shown on attached Figure 3.2. These improvements were undertaken concurrently with the widening of Hodges Blvd between Beach Blvd and Atlantic Blvd (SJRWMD Permit #4-031-17631-6). Per the SJRWMD Technical Staff Report of June 28, 2007, the canal improvements were permitted concurrently with the roadway widening since the latter resulted in direct discharges from Hodges Blvd to Sandalwood Canal. From its outfall at the Hogpen Creek marsh, the canal then takes a meandering path through the marsh, and crosses the Ellis property (see Figure 1.2) before joining with Hogpen Creek just west of San Pablo Road.

Stormwater runoff from the northern section of the Hodges Road alignment (from Sandalwood Canal to Atlantic Blvd) is routed through a series of existing retention ponds, some of which were modified and/or enlarged to accommodate the additional roadway runoff, before being discharged to the north into Greenfield Creek (see the attached Figure 3.2).

For the southern section of the Hodges Blvd alignment, from Beach Blvd to Sandalwood Canal (as shown in Figure 3.2), no suitable options were identified to provide stormwater treatment and attenuation for roadway runoff. Stormwater runoff from this section of Hodges Road discharges directly into Sandalwood Canal, through a system of curb and gutter, inlets and storm sewers.

Project Name:  
**Hodges Blvd and Sandalwood Canal Improvements**  
**LaRue Ellis Property**
